The teardown

Our 1974 Kawasaki Z1A project bike was in worse condition than we thought when we got it back to the workshop last month. Now Rod begins to dismantle it, and finds further horrors are still to come.

the rebuild > kawasaki 900 part two

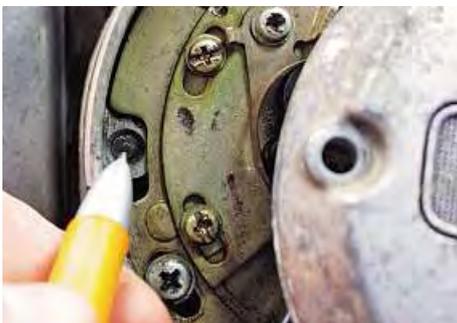
01: Right, time to get the spanners out and get involved. I'm starting with the points cover – as it's held on with masking tape it won't take much to remove it. As I suspected, one of the cover screws has been snapped off in the points housing. The broken end might be tricky to remove, but I'll deal with that once the engine is stripped. The good news is that the points cover itself is intact – the early Z1 cover is not easily available and later supersessions had a different graphic, which would spoil the bike's original looks. The inner points housing has a ding at one edge, but it should be repairable.

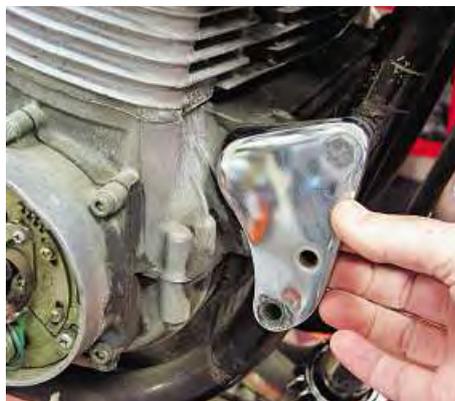
02: These big chrome plates have been bolted to the bike over the front engine mountings, and it takes a bit of head scratching to realise they are probably aftermarket mountings for a set of cruiser pegs. Might look strange to our eyes in the UK, but pseudo chopper parts were very fashionable in the US at one time. If that's all the 'customising' that has been carried out by a previous owner the bike has escaped fairly unscathed. In the bin with them.

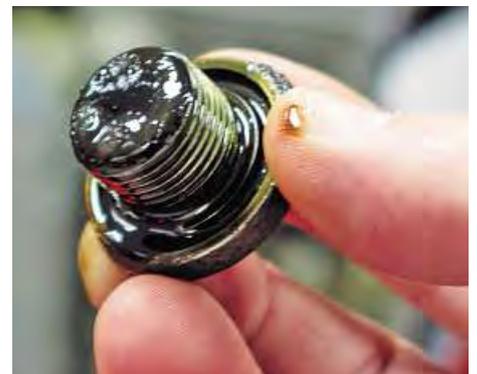
03: While I'm working on the rest of the bike I'll remove the oil drain plugs, so any old lubricant in there can drain safely away. Encouragingly, the sump drain bolt unscrews fairly easily – these can be tight on older Z1s and I've even heard of someone cracking a sump while trying to unscrew one. The drain bolt is magnetic and has a fair bit of metallic sludge stuck to it. Possibly evidence of missed oil changes, which somehow doesn't surprise me. Hopefully the engine internals aren't too bad.

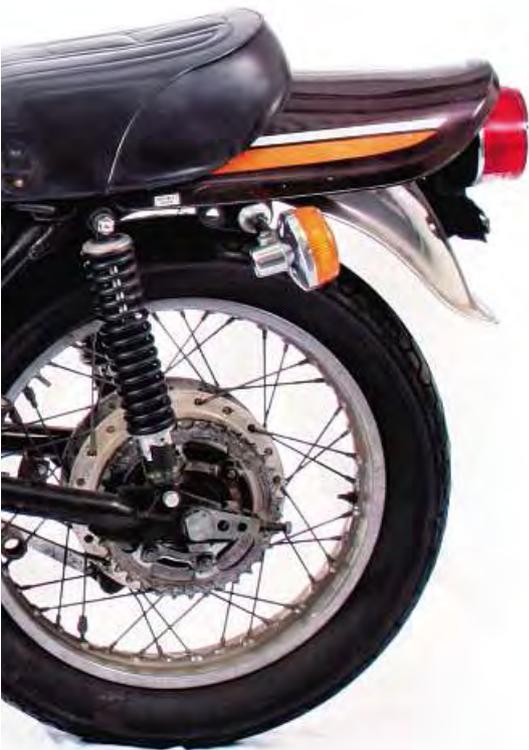
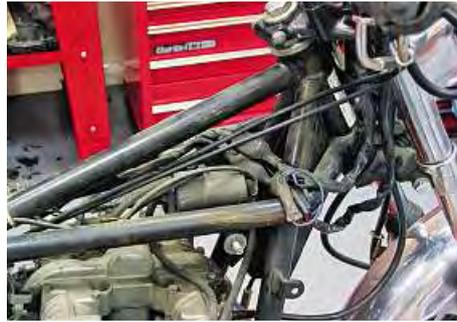
04: Up at the top end, I'm pausing to take loads of pictures of the cable and wiring runs before removing anything. On a bike of this age, and with an unknown history, there's no guarantee that everything is correctly routed to begin with, but a photographic reference is still useful to have. On this bike the main harness runs along the top left frame tube towards the headstock, and the handlebar switch wires are at the right. Note the ignition coils bolted to the frame tubes – these have bonded HT leads that have hardened with age and are now quite brittle. Two new coils required for the rebuild.

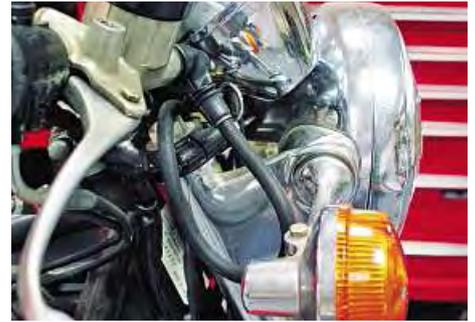
05: Further up and the mystery of the enormously long brake hose. Although the bike has low bars now it must, at some point, have had enormous ape-hanger bars fitted; someone has changed the bars but simply looped up the excess hose. There is no sign of any brake fluid in the master cylinder and no indication that the brake will work, so this master cylinder may or may not be usable. The anodising has faded to a dull silver, so it will need refinishing and servicing at the very least. Note the bashed headlamp rim and loose tachometer bottom cover.

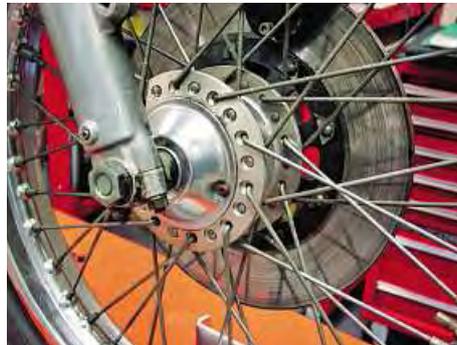
06: The caliper and fork legs look original but this is the wrong wheel. The Z1, Z1A and Z1B were fitted with the front end from the H2, and should have a black wheelhub with six mounting bolts for the disc. This hub is silver and carries a four-bolt disc, which probably marks it out as either a Z900A4 or Z650B item. The front axle with sleeve nuts is also incorrect for the Z1A. Although it all seems to fit together quite well, I'm wondering if the bike has been accident damaged and fitted with a different wheel to repair it?

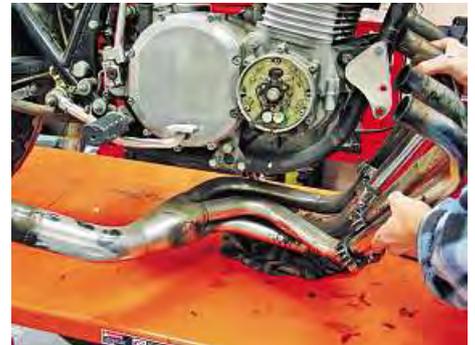
07: Right, let's start unbolting stuff. The remnants of the hideous 4:1 exhaust system unbolts fairly easily and goes in the skip outside. I'm saving the exhaust mounting collars and flanges, as they're the correct, original parts and will clean up. One of the finned collars seems to be tight against the frame as it comes away – I'll have good look at that when I've made more room to work. The front of the engine is coated in oily sludge, but it's no real cause for concern and it might have just helped prevent corrosion over the years.

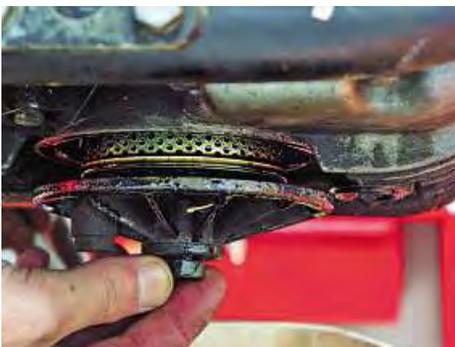
08: Now I can get at it I'll remove the oil filter. The central bolt comes free easily – again these are frequently tight on older bikes and can put up quite a struggle. At least the bike has an oil filter fitted and it's the correct type. This large diameter metal shrouded filter was only used on the early Z1 and Z1000 series and the Z750 twins. Later bikes have a smaller, paper filter identical to the sohc Honda 750, and I've seen the later filter boded into early housings before. There's a good amount of thick, black sludge in there, but at least it's oil and not rusty water.

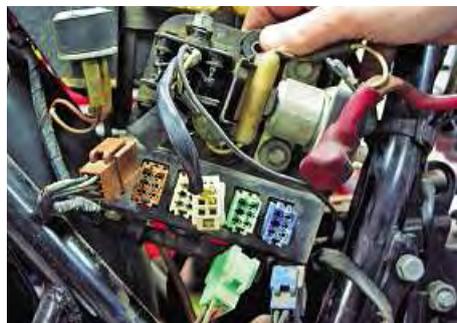
09: While the remnants of the old oil dribble out I've moved round to the right-hand side of the bike to begin to dismantle the electrics. This plate bolted to the right side of the battery carrier carries the solenoid and rectifier, and a small sub-harness that has the coloured block connectors for the harness connections. It all looks in surprisingly good shape, though I'm beginning to notice that all the rubber mountings on this bike are perished, probably from years of exposure to the hot Utah sunshine. Sorting out the wiring routing can be a pain later, so again I'm taking loads of photos of these parts as they are unbolted and stored away.

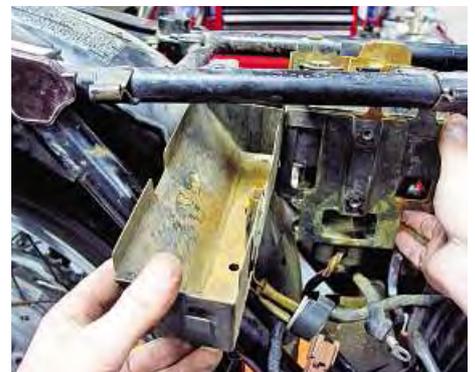
10: Now the battery carrier and tool tray can come off. Judging by the surface rust and dry, whitish gunge on the battery tray it's a fair bet that the battery has been overcharging on this bike. It's a common fault on Z1s, but it won't have been helped by the high temperatures in which this example has lived most of its life. Blotchy patches on the chrome on the rear wheel rim and brake torque arm are consistent with battery acid spills too. The battery itself is, of course, bone dry and thoroughly goosed, but we expected that.

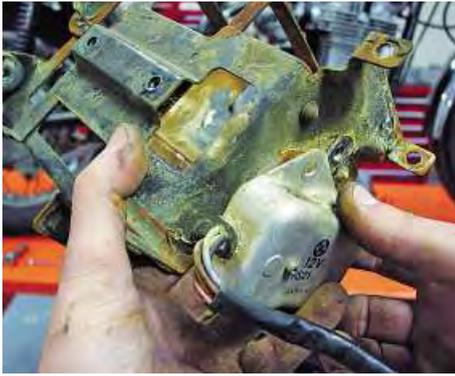
11: The regulator is a separate item on the Z1, and is bolted underneath the battery tray. It might still even work, but I reckon it will be prudent to convert the bike to a more modern, and more reliable, charging system when I rebuild it. Unlike the Z750B or Z650B1 the Z1 has a three-wire alternator, so it's quite easy to fit a modern combined regulator/rectifier unit. With the dried up remnants of the rubber mountings removed, labelled and stored the battery tray and toolbox goes in the pile for powder coating.

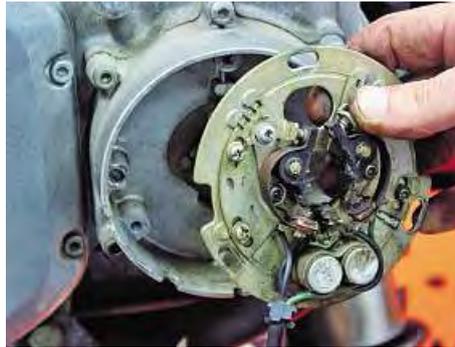
12: As I'm stripping the bike I'm sorting all the bits for renovation, further dismantling or storage. It makes sense to remove the points backplate and store it with the other electrical components for now, so I'll have a Big Box of Electrical Stuff to sort through later. Personally, I like to start up restored bikes on the original points ignition where possible – it makes any troubleshooting easier without introducing unknown elements into the equation. For that reason I'll be fitting new points and condensers for the initial start-up, and once the bike is running I'll be looking at converting to electronic ignition of some kind.

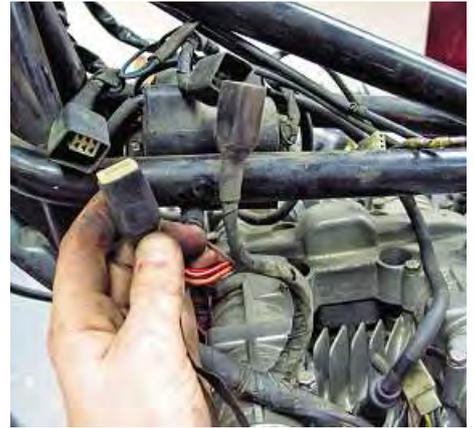
13: Time to unplug the harness and unbolt the coils, and store them all away in the Big Box of Electrical Stuff for sorting out later on. A quick examination shows the harness to be in pretty sound nick – there's no obvious signs of bits of bodged wiring repairs that we see so often. Even the block connectors look pretty good, but it will all be cleaned up and checked over before I assume any of it is fit to reuse.

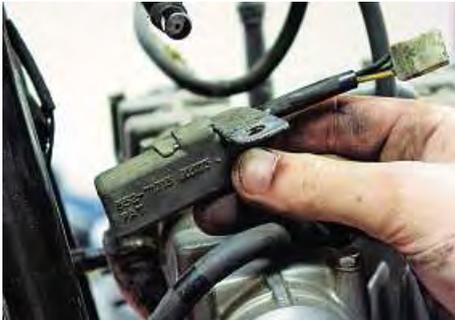
14: One of the quirky bits on the Z1 is this device bolted to the left-hand ignition coil. Its function in life is to control a warning lamp on the tachometer face that notifies you if your stop-lamp bulb is not working. There are signs that the block connector on this example has been overheating. To be frank, I don't ever remember coming across a bike that had this function working, and when they packed up on customers' bikes we simply used to remove them. If it works it will be a novelty – if doesn't I might even go the extra mile and fit a new one for the sake of originality, if I can be bothered.

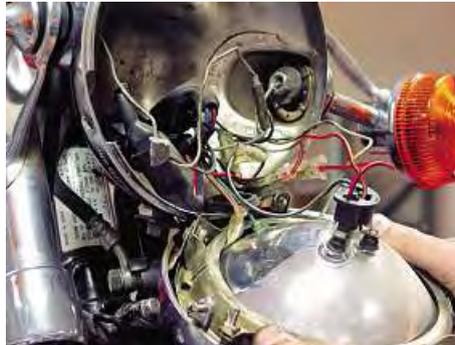
15: Broken winker earth mounts in the headlamp shell are further evidence of accident damage. The wiring itself looks fairly sound, except for the unused sidelight connections, which have been clamped between the headlamp unit and its inner rim. Helps keep it tidy I suppose, but I'd rather not risk it chafing through to metal and blowing the main fuse each time the lights are switched on. The headlamp unit is in fine condition but dips the wrong way for UK roads, so a new one goes on the growing shopping list.

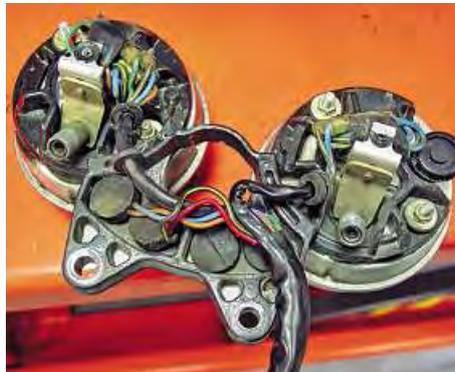
17: The clock assembly comes away from the top yoke after removing two bolts. Again, all the rubber mountings are perished so everything's wobblier than it should be, but that's all easily fixable. The tachometer head, though, is quite obviously damaged so I'll be going shopping for a second-hand item to replace it. This lot will dismantle further, but again I'm taking lots of pictures of the wiring to help me put it back together correctly when I rebuild the bike later.

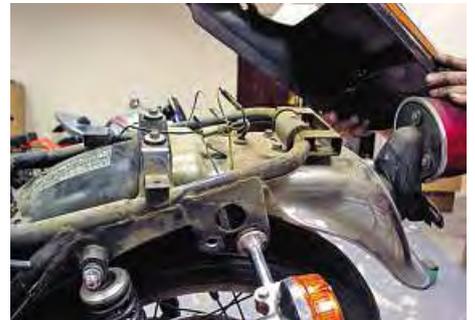
18: At the back end of the bike the trademark Kawasaki tailpiece lifts away after I've removed its four rubber mountings. Beneath it we have the rear fender front and rear fender rear. The two central bolts that attach these to the frame are almost always rusted in solidly on UK bikes – these unbolt without any drama. Ah, the joy of working on a Utah import! Note the wipers mounted to the frame – from the Z900A4 onwards they were mounted to the grabrail. Deep joy – the rear section mudguard is solid and will re-chrome easily. Replacements are easy to get these days, but the UK spec long mudguard is still a rare and valuable find.

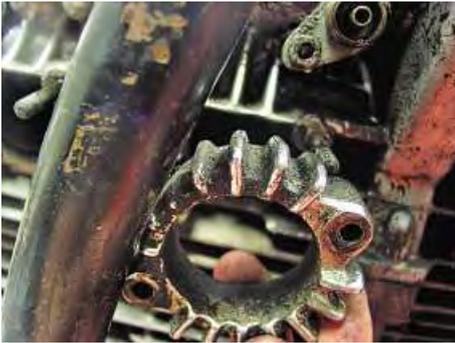
19: No putting it off any longer – something was wrong with those exhaust clamps hitting the frame downtubes. The clamps have fins relieved on one face to clear the inside of the frame on numbers two and three, but here the number two clamp is hard up against the frame. Number three, by contrast, has a good half an inch of clearance. I've already noticed buckling on the front engine plate, and the main front engine bolt is bent. There's only one conclusion – the frame is bent. It all adds up – the scuff marks on the frame and engine, the wrong front wheel fitted and mountings for highway pegs that are strangely missing.

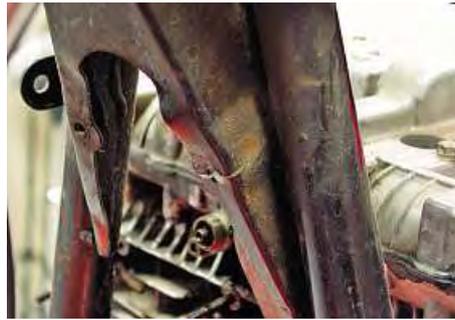
20: Now I notice this cracking at the headstock gussets. Close examination of the front downtubes shows indentations above each front engine mount. I reckon the bike has been fitted with crashbars, then heavily binned. The crashbars have bent the frame, and it's all been cobbled together with a different wheel and handlebars and moved on. Time to stop and think about this – now would be a good time to abandon the project, sell the bits for a profit and forget all about it. But I'm made of dafter stuff, and am beginning to feel like I'm on a mission. It all makes me more determined to not only repair this bike, but to rebuild it to show standard. Onwards and upwards.

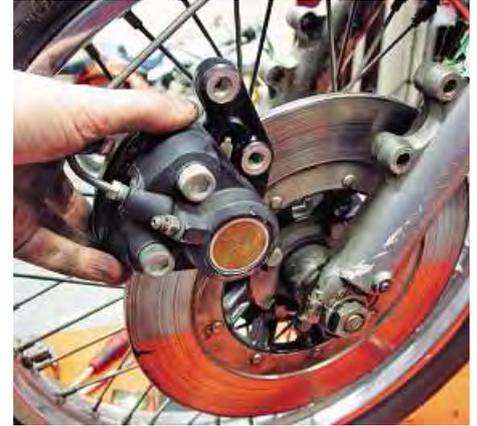
21: The caliper is correct for the Z1 at least, and it looks to be in fairly good nick, apart from a little light scuffing. I have no idea if it actually works, but for now I'll unbolt it and store it for a full strip down later. The marks on the fork leg could be accident damaged, or could simply have been caused by the bike rattling around in a transatlantic container. The sticker on the fork leg is an authentic touch of the bike's US heritage.

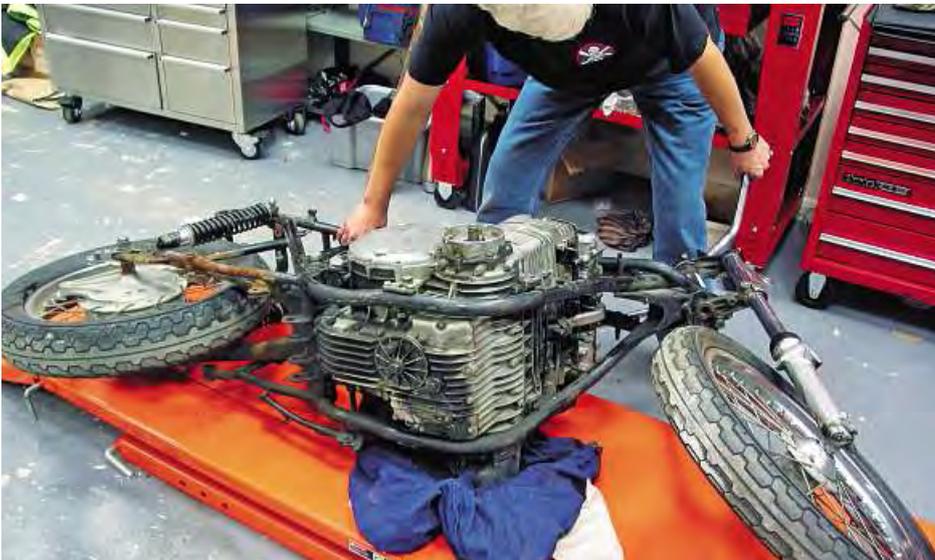
22: Next job – engine out. With rags on the bench to prevent any more scuffing, the bike now goes over sideways. I'm taking the engine out as one lump, and will treat it as a project in itself. With all the weight on the engine I can now remove the wheels and suspension, leaving me with the fairly easy task of lifting the main frame loop off the engine on the bench. At this stage it's also easy to get at the main engine mounting bolts and loosen them all off.

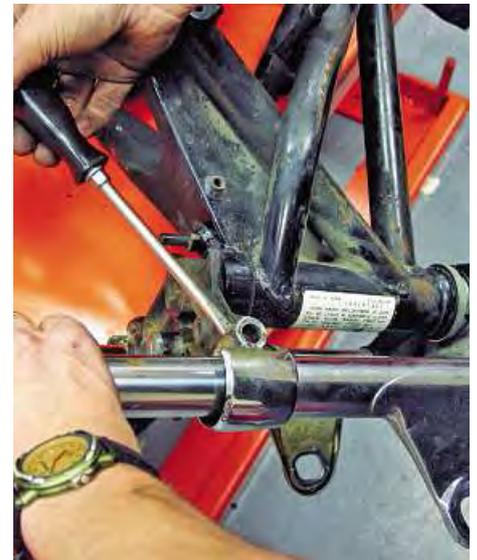
23: The front wheel unbolts easily, and I can then turn to removing the fork legs. Slackening off the pinch bolts on the yokes should make them loose enough to twist out, but these are still tight. The easiest solution is to remove the pinch bolts entirely and shove a screwdriver into the gap in the yoke. A little gently leverage will then open up the bottom yoke far enough to release the fork leg, which can then be twisted and wiggled free. The bottom yoke is steel and quite sturdy, but be careful if you have to do this at the top yoke – the alloy can fracture if you're too rough with it. The headlamp brackets and fork shrouds have a selection of rubber O-rings and cups, all of which are carefully collected and stored for later use.

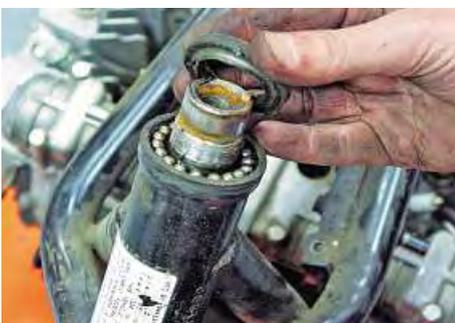
24: Now, at last, the top yoke can be removed. The head bearings were a little notchy but I intend to fit taper rollers as part of the rebuild. While I want to (hopefully one day) experience the undiluted Z1A riding experience I fully intend to take advantage of modern bearing technology at both the steering head and swingarm pivot. It's hard to imagine a time when cup and cone bearings from a bicycle were considered adequate for the most powerful production motorcycle in the showrooms.

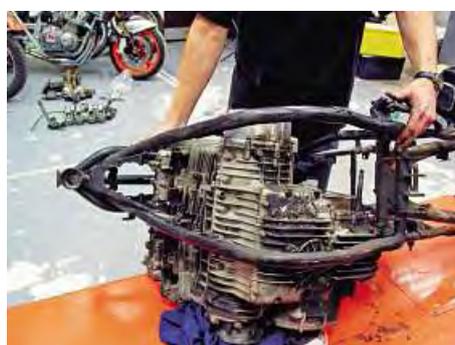
25: With all the peripherals removed I can now remove the engine bolts and lift the frame off the engine. It's a bit of a wiggle to clear it, but at this stage I'm not worried about scratching any paintwork. The engine will stay on the bench for stripping down, and I now have a big pile of dirty, greasy parts to clean up and check over before sending them out for re-finishing. And then, I'll have to come up with a plan for the bent frame.
